### Inspection Report

#### Minerals Regulatory Program

**Mine Name:** Judy #1

**Permit number:** S/019/047

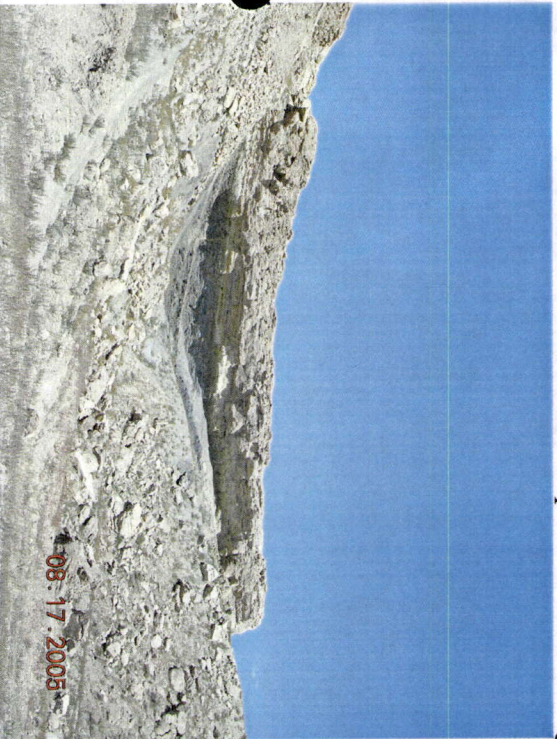
It appears the operator created a road from the main Crystal Geyser road to the mine, but recreationists have taken off from the original road and made their own trails. As one proceeds toward the mine site under the overhang in Photo 1, I do not believe the road would be passable in a normal 4-wheel-drive vehicle.

The overhang shown in Photo 1 appears to be a natural feature. I don't believe there is any particular danger to the public created by the presence of an unreclaimed mine except if people run off the roads and overturn. These same hazards exist in many nearby areas.

Photo 1. The mine is on top of the mesa in the center of this photo. The access road goes under the overhang which appears to be a natural feature.

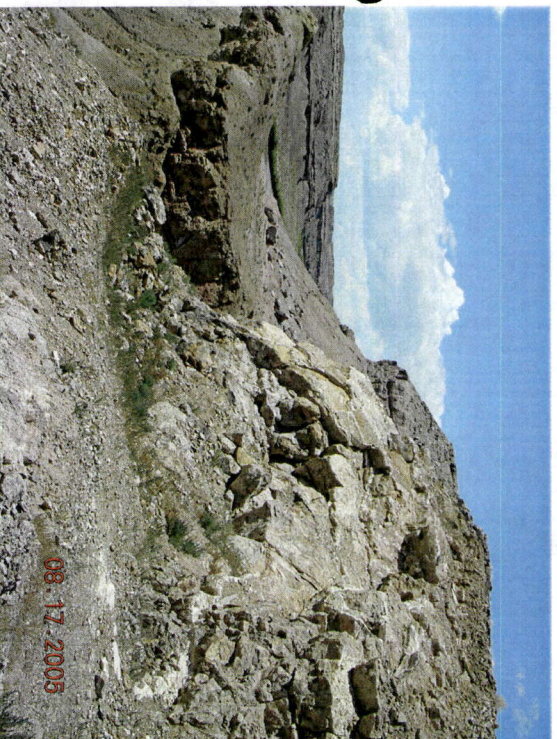
This former travertine mine site is located on top of a mesa overlooking the Green River (Photo 1). The top of the mesa is a rock outcrop (Photo 4), but there is some vegetation in adjacent areas. Photos 2 and 3 show where it looks like the operator took some rock, but most appears to have come from the top.

Photo 2. A small area off the top of the mesa that appears to have been mined.

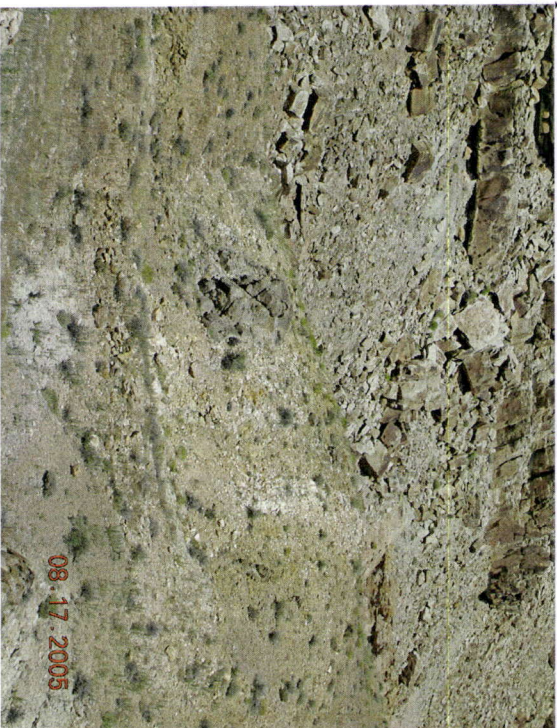
Photo 3. Looking down from the top of the mesa. There may have been a small amount of mining in this area.

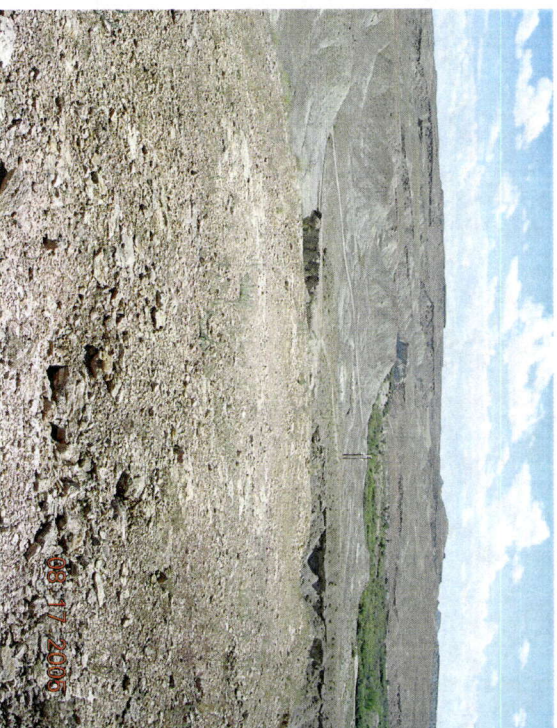
Photo 4. The mesa top where most activity appears to have taken place.
